*City of Portland Bureau of Transportation*  
**Asset Status and Condition Report 2013**

**CITY OF PORTLAND  
BUREAU OF TRANSPORTATION**

Information current through July 2013. Published January 2014

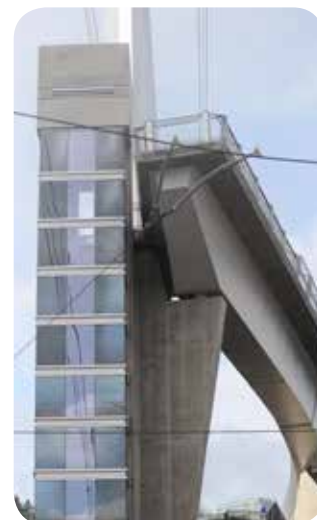
*The Gibbs St. Pedestrian Bridge shown below opened on July 14, 2012. The eastern end is accessed by an elevator tower.*

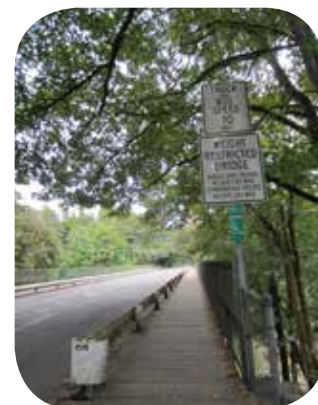
*NW Thurman Bridge over Balch Creek will receive modernization upgrades in 2014, eliminating the current weight restriction and replacing the plank walkway for pedestrians with skid-resistant aluminum.*

*sustainable approach than replacing an entire bridge. In 2014, PBOT will use City and federal grant funding to carry out substantial rehabilitation to the NW Thurman Ave Bridge over Balch Creek. This project will preserve an historic 108-year-old bridge, and renew it for decades of future service. ■*

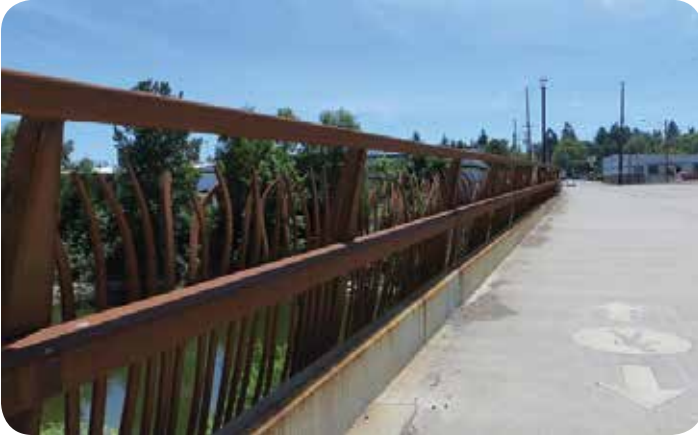
A bridge on N. Vancouver Ave. over the Columbia Slough opened to the public in 2010

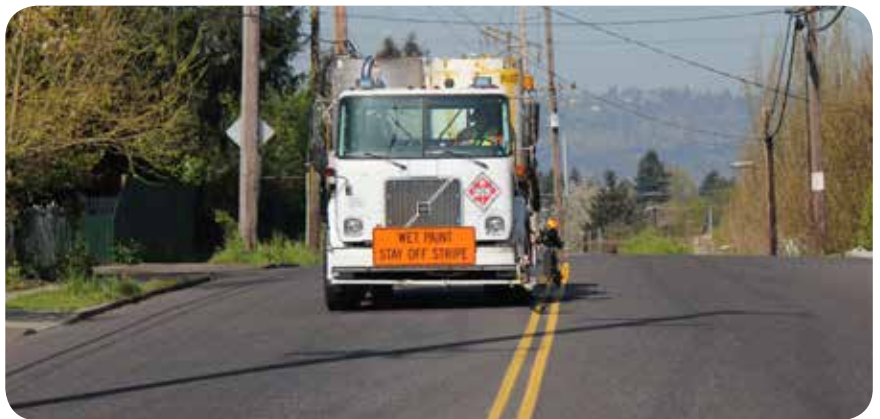
*A striping crew repainting double yellow lines*

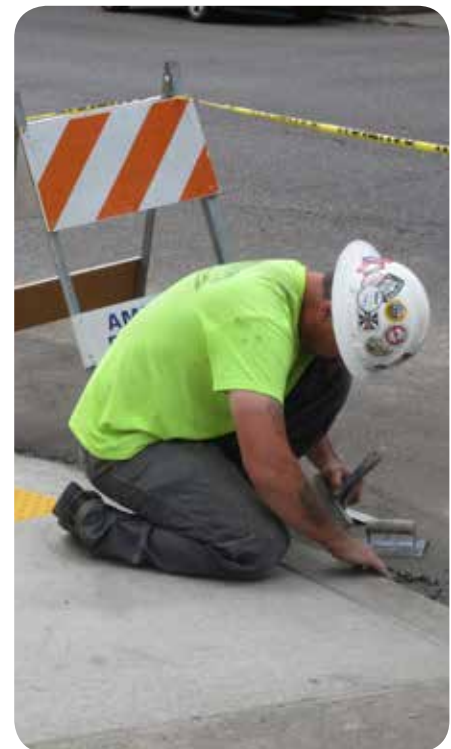
*Installing an ADA compliant curb ramp in Northwest Portland.*

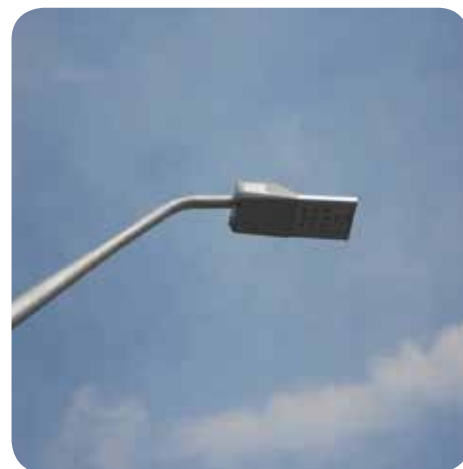
*Newly installed LED luminaire on Marine Drive*

- ✓ Negotiations are ongoing with Portland General Electric regarding the City's proposal to convert 46,700 street lights from high pressure sodium to energy-efficient Light-Emitting Diodes (LED). PBOT anticipates achieving savings due to lower energy use and lower maintenance and operations costs. The conversion is expected to be implemented fully over the next five years beginning in December 2013. To date, more than 600 LED fixtures have been installed by City staff. ■

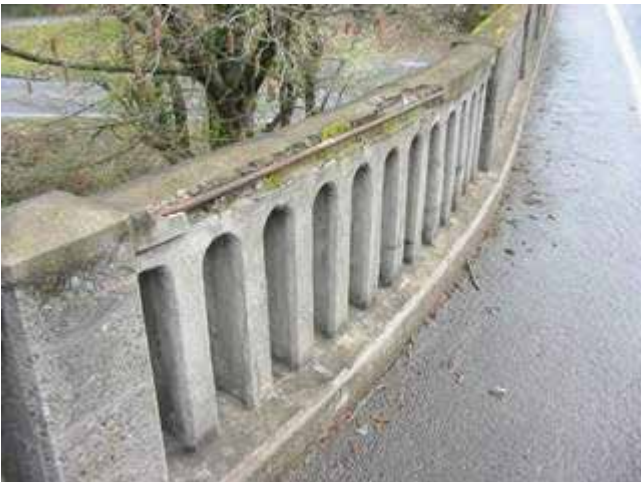
DESCRIPTION	NBI CONDITION RATING (Items 58, 59 & 60)	2013 CONDITION
  <p>N Vancouver Ave over Columbia Slough (Rail) – This bridge was rebuilt; however, the picture is representative of fair condition.</p>	<p><b>FAIR</b> Primary structural elements are sound but may have minor cracking or spalling.</p>	5-6	32%
  <p>SW Vista Ave over Jefferson Ave (Rail)</p>	<p><b>POOR</b> Deterioration of structural elements and/or weight restricted.</p>	4	17%

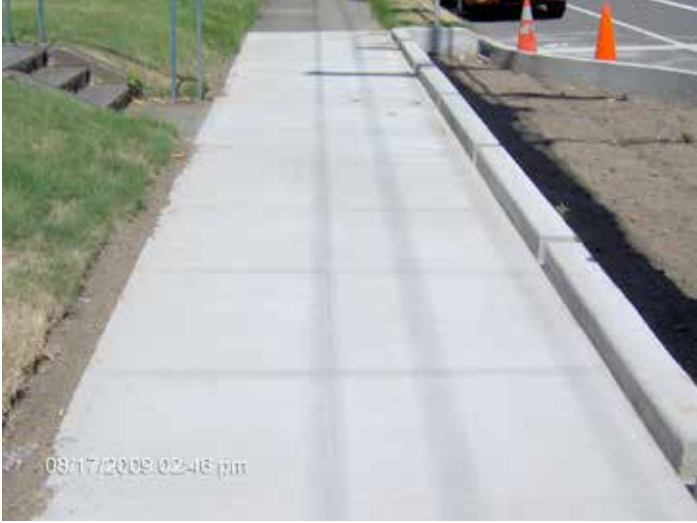
<p><b>VERY GOOD</b> Newer concrete at correct slope and grade. No cracking beyond control joints. No step separations, spalls, or openings.</p>	10%

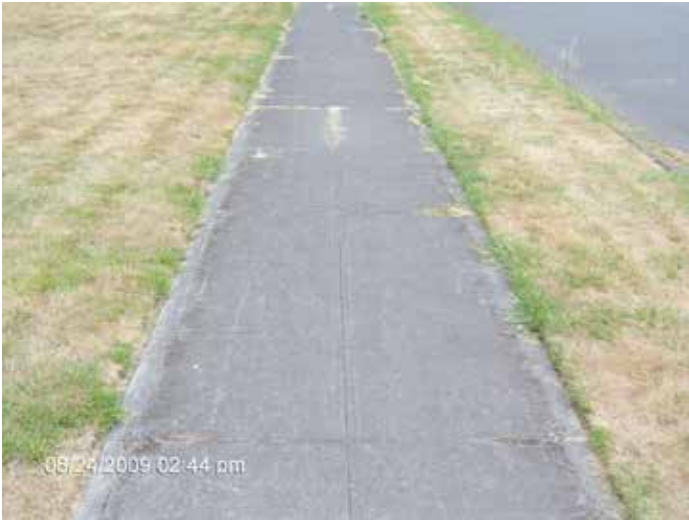
<p><b>GOOD</b> Correct slope and grade. Some cracking beyond control joints. No step separations, spalls, or openings.</p>	25%

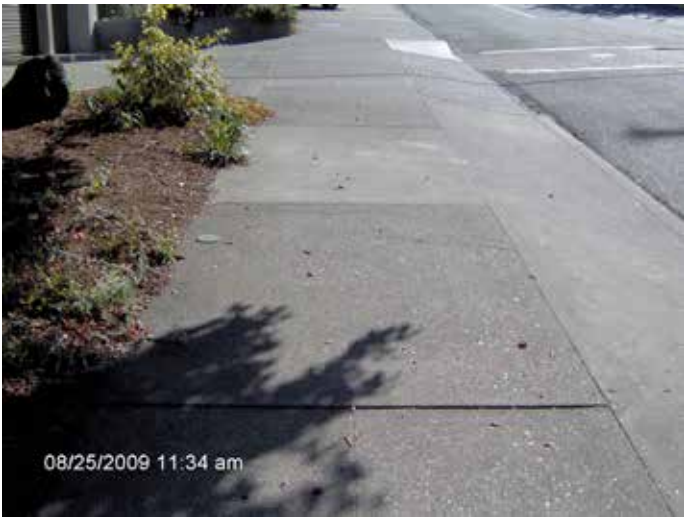
<p><b>FAIR</b> Correct slope and grade. Some step separations, spalls, and openings less than ½ inch.</p>	30%

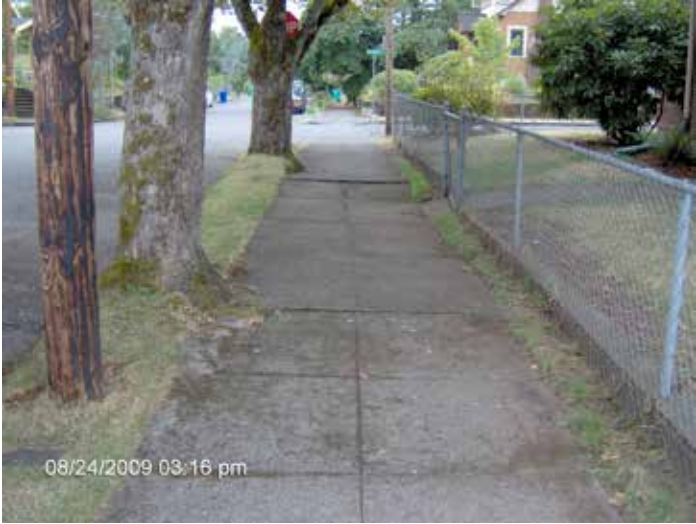
<p><b>POOR</b> Some raised and/or sunken areas. Step separations, spalls, and openings greater than ½ inch.</p>	25%

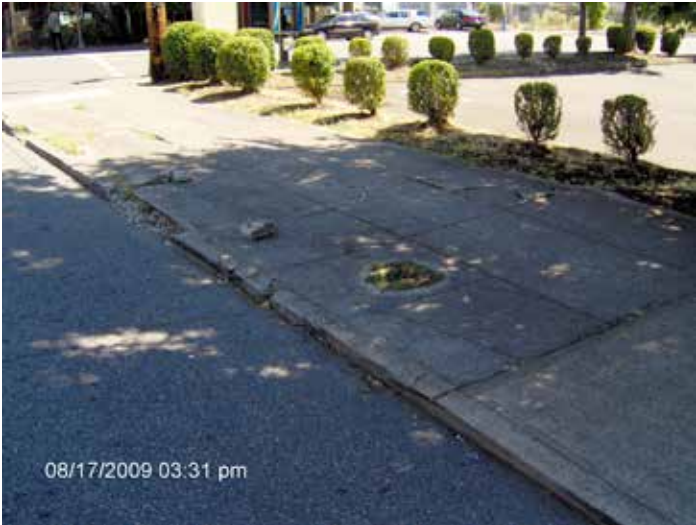
<p><b>VERY POOR</b> Some raised and/or sunken areas more than 4 inches from original grade. Step separations, spalls, and openings greater than ½ inch. Some areas of sidewalk missing.</p>	10%

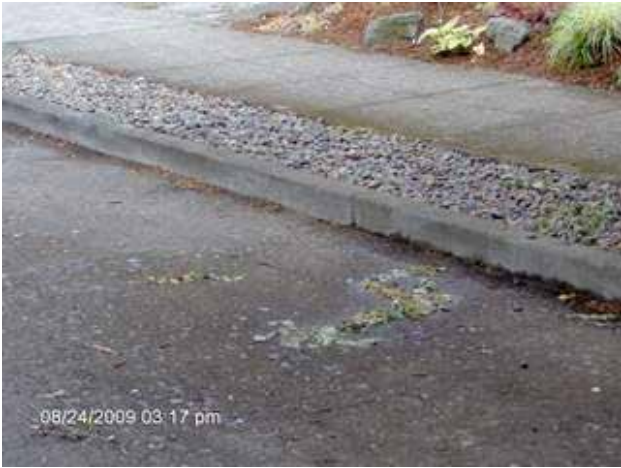
<p><b>VERY GOOD</b> Newer curb on correct slope and grade. No cracking beyond control joints. No spalls or openings.</p>	12%

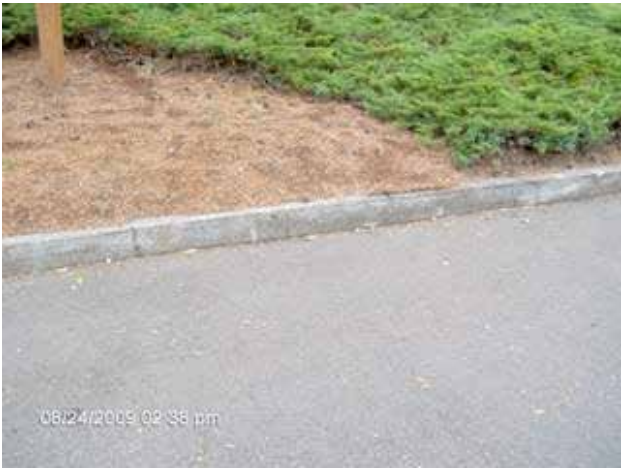
<p><b>GOOD</b> On correct slope and grade. Some cracking beyond control joints. No spalls or openings.</p>	50%

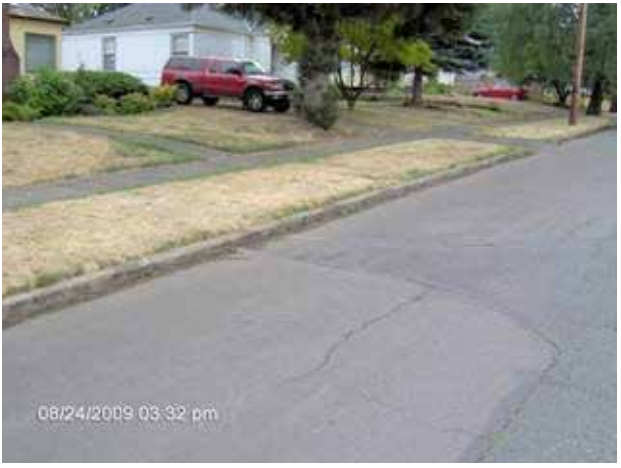
<p><b>FAIR</b> On correct slope and grade. Some cracking beyond control joints. Some spalls and openings less than ½ inch.</p>	16%

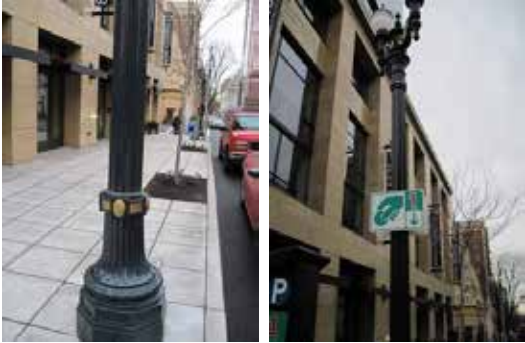
<p>Ornamental – Option C Light</p>		<p><b>VERY GOOD</b></p> <p>The street light is in new/near new condition. Everything is working properly. Re-lamping and photocell replacement is the usually the only requirement, but inspection of the pole and control systems should also be performed to confirm that everything is functioning normally.</p> <p>Age: less than 5 years</p>	<p>Option C: 8%</p> <p>Option B: 3%</p>

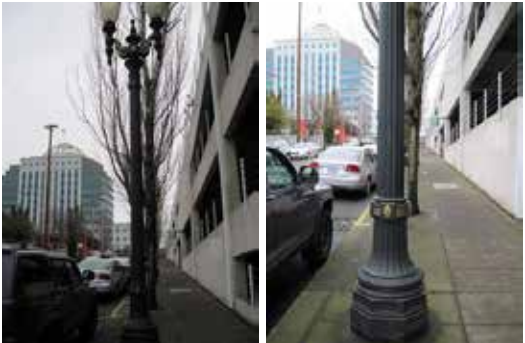
<p>Ornamental – Option C Light</p>		<p><b>GOOD</b></p> <p>Scheduled preventive maintenance will keep the street light operational for the expected design life. Tree trimming around street lights may be necessary so that light is not obstructed from the roadway surface.</p> <p>Age: 6 - 15 years</p>	<p>Option C: 28%</p> <p>Option B: 8%</p>

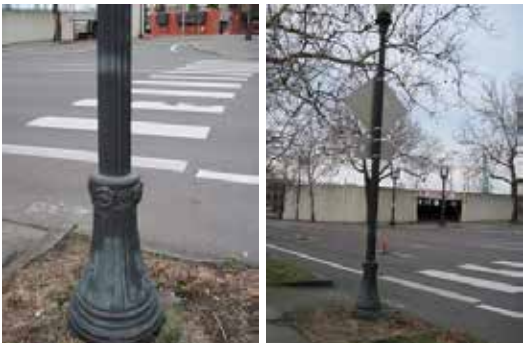
<p>Ornamental – Option C Light</p>		<p><b>FAIR</b></p> <p>The luminaire, pole, and control systems require regular preventive maintenance to keep the street light in operational status. Tree trimming around street lights may be necessary so that light is not obstructed from the roadway surface.</p> <p>Age: 16 - 25 years</p>	<p>Option C: 42%</p> <p>Option B: 36%</p>

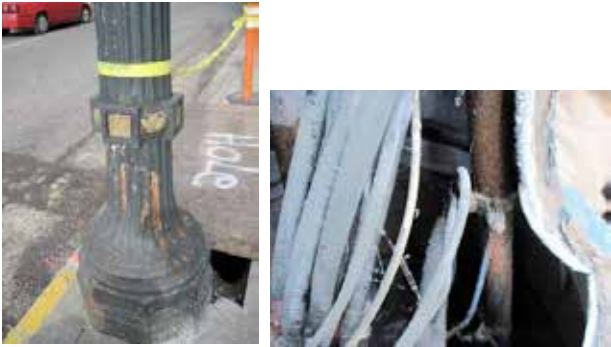
Ornamental – Option C Light    Anchor Bolt Deterioration		<p><b>VERY POOR</b></p> <p>The entire street lighting infrastructure has reached its intended design life and is in need of replacement. Replacement includes the luminaire, supporting arm, pole, wiring, and control systems.</p> <p>Age: Over 30 years</p>	<p>Option C: 12%</p> <p>Option B: 16%</p>

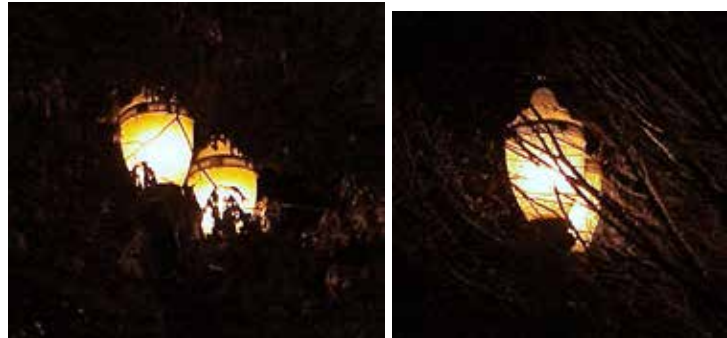
<p>Twin Ornaments (Option C) blocked by tree branches – reducing effectiveness of lighting.</p>	
EXAMPLES OF OPTION B LIGHTING:

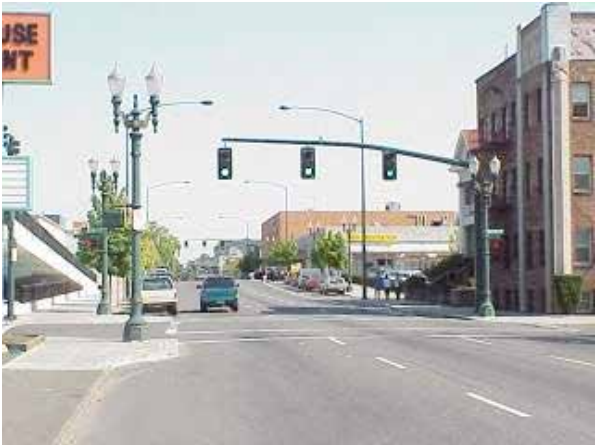
<p><b>VERY GOOD</b></p> <p>The signal is in new/near new condition. Everything is working properly. Preventive maintenance of the traffic signal cabinet is the major requirement, but examination of the hardware to be sure everything is nominal is the primary preventive maintenance activity for the hardware.</p> <p>Age: less than 7 years</p>	13%

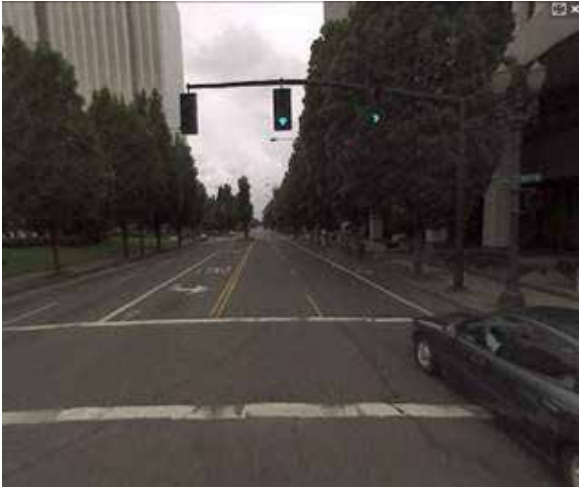
<p><b>GOOD</b></p> <p>Normally scheduled preventive maintenance will keep the signal operational for the expected design life. Timing should be examined and altered to be sure that it meets the operational needs of the intersection.</p> <p>Age: 8 - 14 years</p>	16%

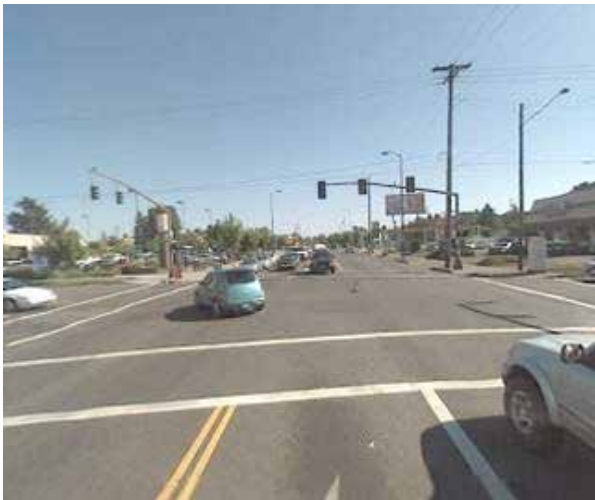
<p><b>FAIR</b></p> <p>The hardware infrastructure needs regular preventive maintenance to keep the signal in operational status. The signal controller is most likely at the end of its useful life, but a change out of the traffic signal cabinet or a partial replacement of the controller is likely to be needed.</p> <p>Age: 15 - 25 years</p>	19%

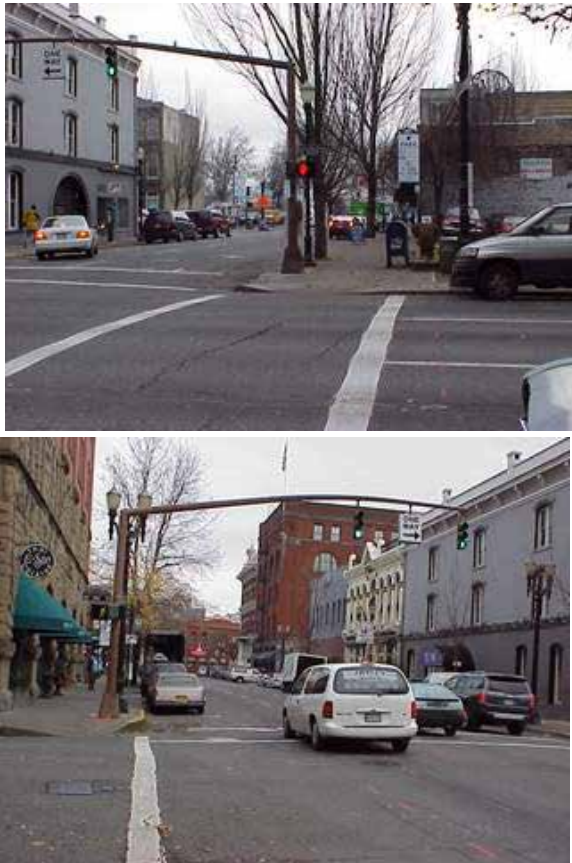
<p><b>POOR</b></p> <p>The hardware infrastructure is close to the end of its useful design life. Operational failures have increased due to wiring and support hardware problems. Preventive maintenance can't reasonably extend the life much longer.</p> <p>Age: 26 - 35 years</p>	16%

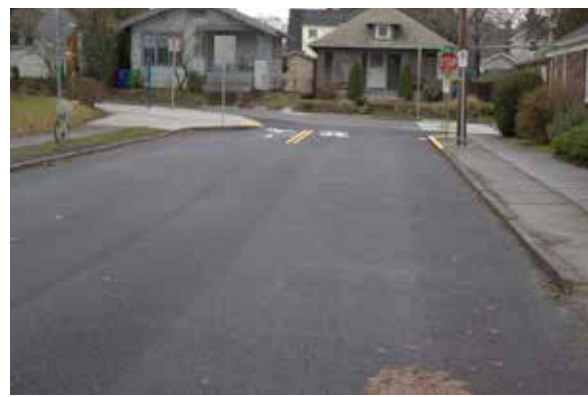
#### VERY GOOD

Pavement structure is stable with no cracking, no patching, no deformation evident. Streets in this condition are fairly new. Riding qualities are excellent. Nothing would improve the street at this time.

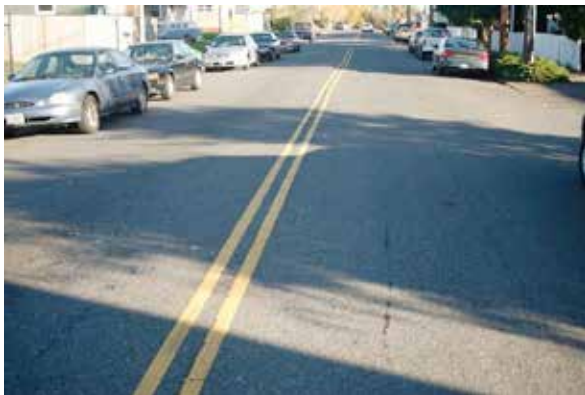
#### GOOD

Pavement structure is stable, but may have surface erosion or minor cracking, minor patching and minor deformation. Riding qualities are very good. Some routine maintenance or rejuvenation of the wearing surface is all that is required.

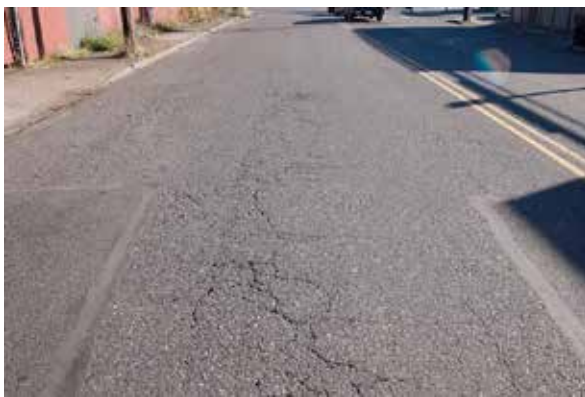
#### FAIR

Pavement structure is generally stable with minor areas of structural weakness evident. Cracking is easier to detect. Although riding qualities are good, deformation is more pronounced and easily noticed. Seal coating or non-structural overlays are required to preserve pavement integrity.

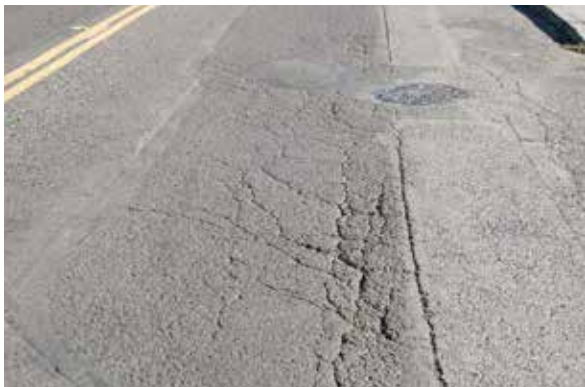
#### POOR

Street has areas of instability, marked evidence of structural deficiency, large crack patterns, alligating, heavy and numerous patches, and very noticeable deformation. Riding qualities range from acceptable to poor. Base repair, grinding, and structural overlays may be required.

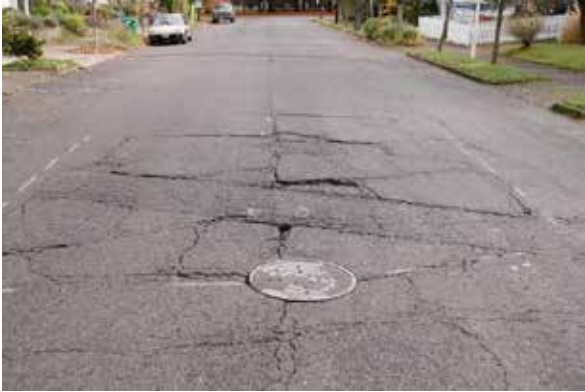
<p><b>VERY POOR</b></p> <p>Cracking and pavement deformation has progressed to the point that pavement is no longer structurally sound. The cost of rehabilitating the existing pavement will likely equal or exceed the cost of complete reconstruction.</p>	0-39	<p>Arterials and Collectors: 11%</p> <p>Locals: 15%</p>

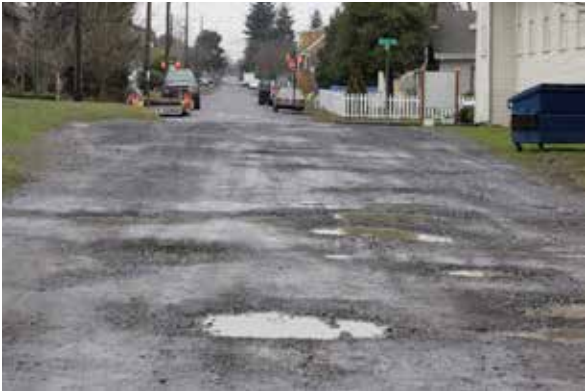
<p><b>UNPAVED</b></p> <p>Unpaved streets which are graded and are either dirt or gravel but for which there is no pavement or drainage.</p> <p>The City does not maintain these streets. Street improvements are made through the LID process.</p>	75-84	56.8 centerline miles
